U-ESR-F-00042
December 15, 2009
Revision 0

Tank 19 Volume Estimation Following Mantis™ Cleaning Operations

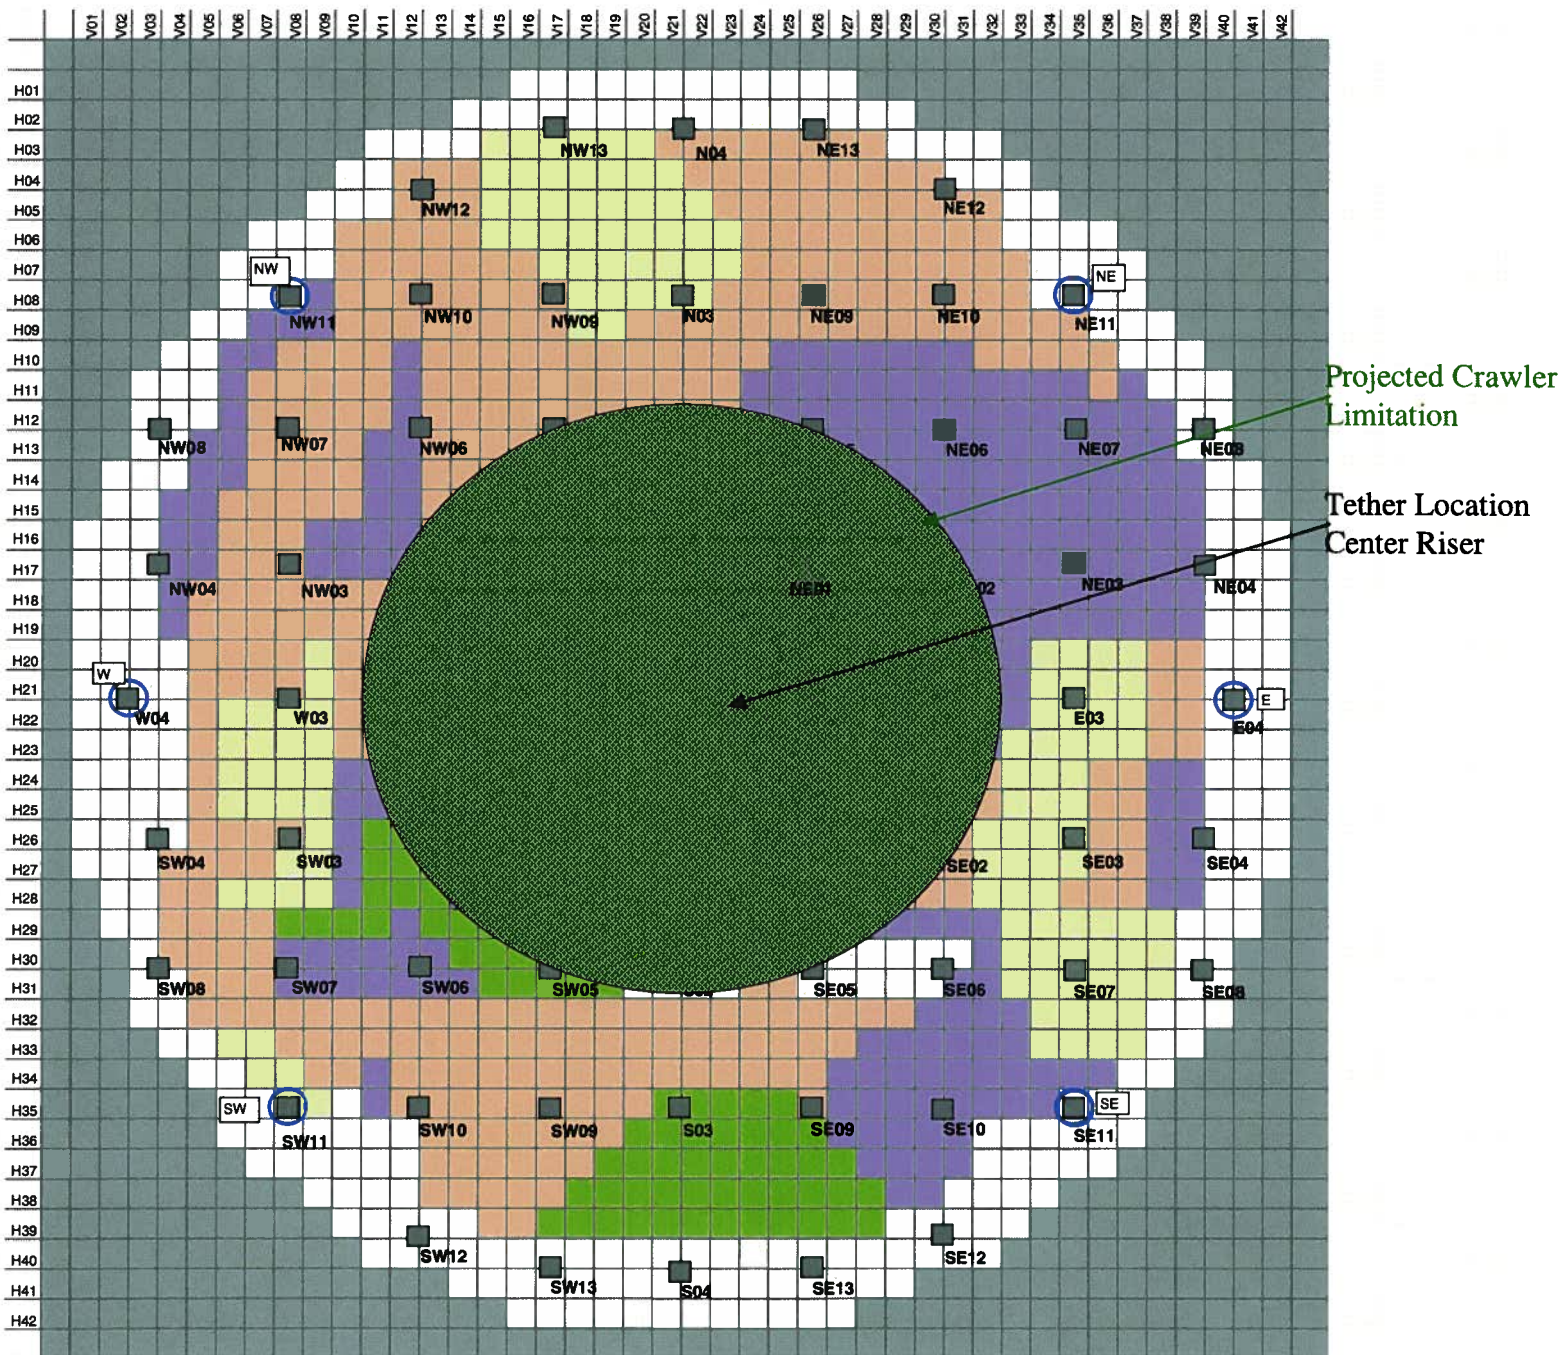
Attachment E Projected Mantis™ Travel Limitations

the Mantis™ inside of Tank 19 would face similar limitations. Engineering predicted the range of travel for the Tank 19 Mantis™, excluded the possibility of gathering data from the outer regions of the tank and showed that only a portion of the central indeterminate region would be surveyed (Attachment E).

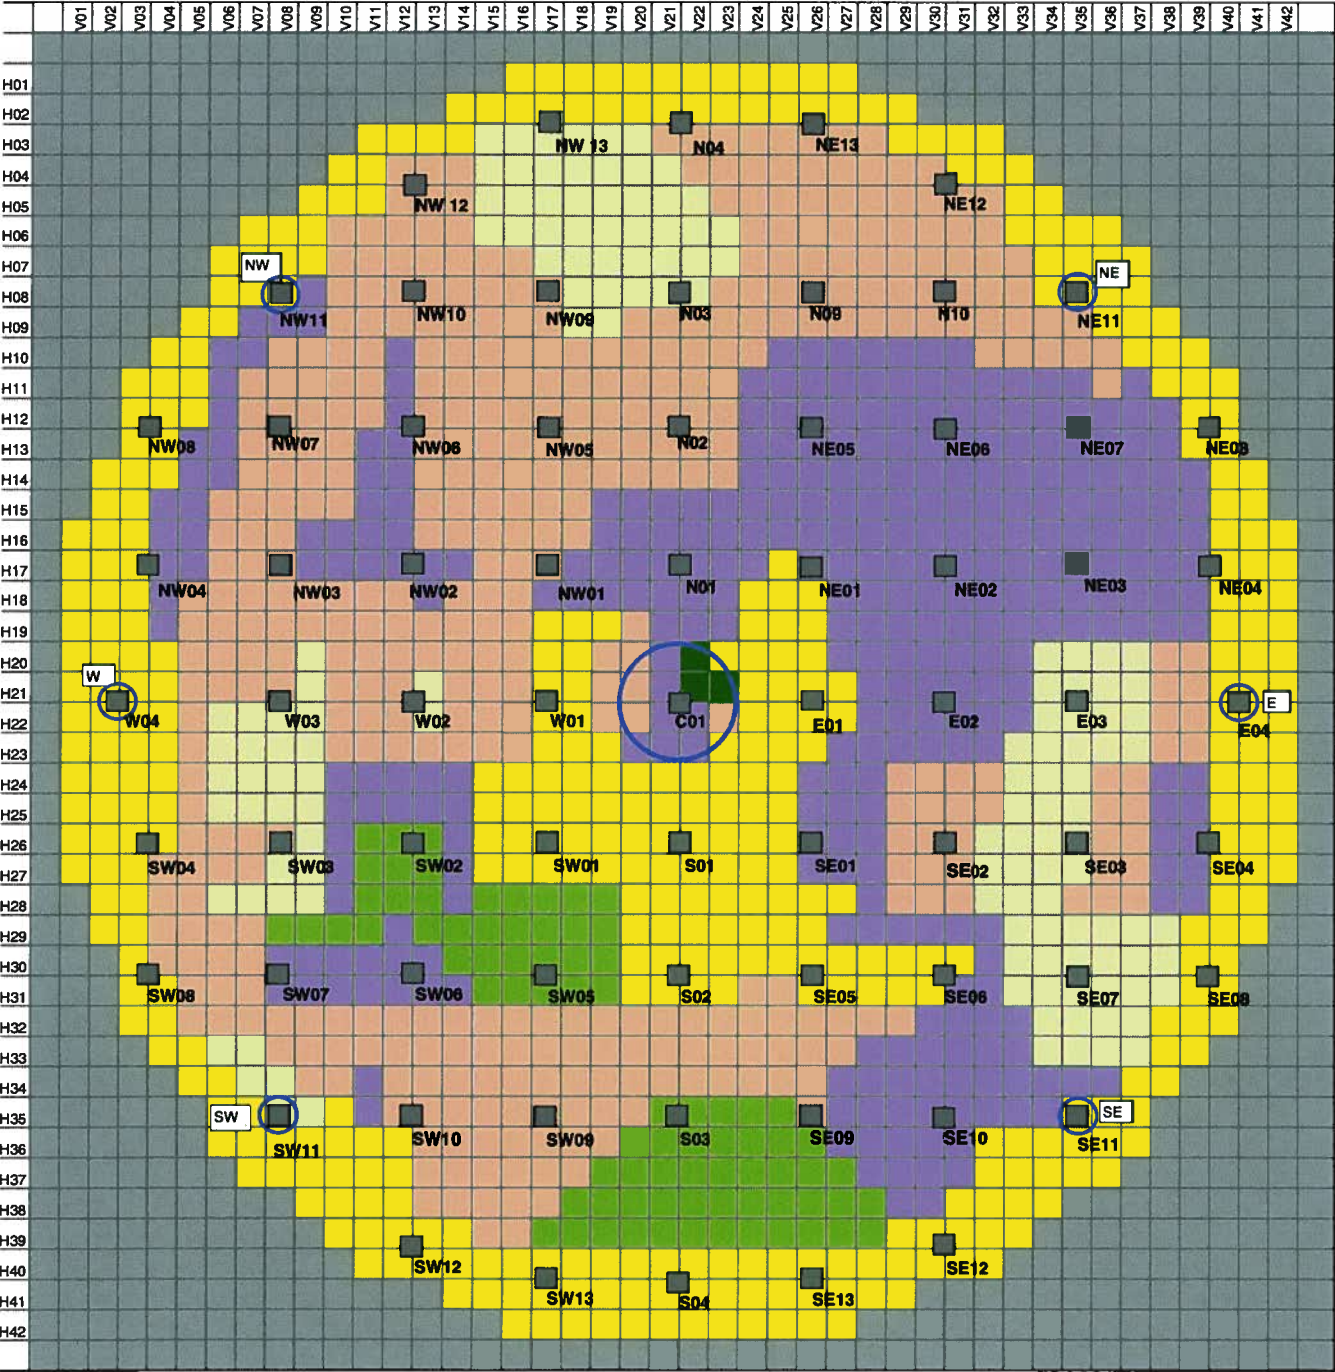
Attachment F
Tank 19 Mapping After Mantis™ Operation

The material depths derived from lifting plates in the digital still photos are listed in Attachment C. The measured and estimated material depth values were then entered into an Excel sheet (Attachment F). Each cell in the sheet represents a 2 foot by 2 foot section of tank floor. Material mapping volumes for each cell were summed giving a final value of 1960 gallons of material remaining in Tank 19.
